Exemplar 96 Mustang airbag sensor (ball Cylinder type)

95 Mustang front airbag sensor with cut wire harness – airbag failed to deploy driver of vehicle was killed

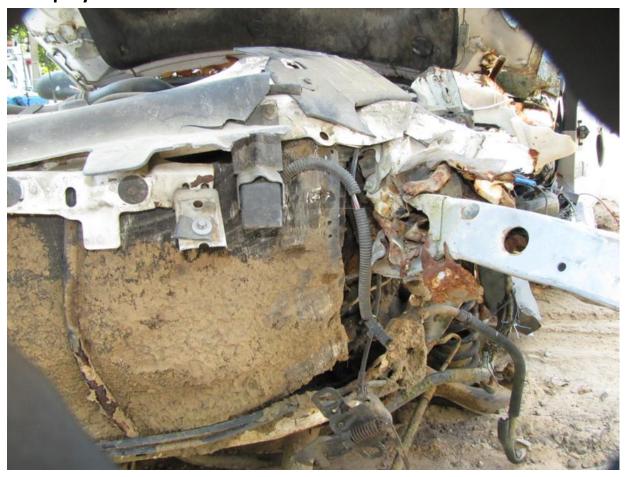
## Cut wire harness of airbag sensor on 95 mustang

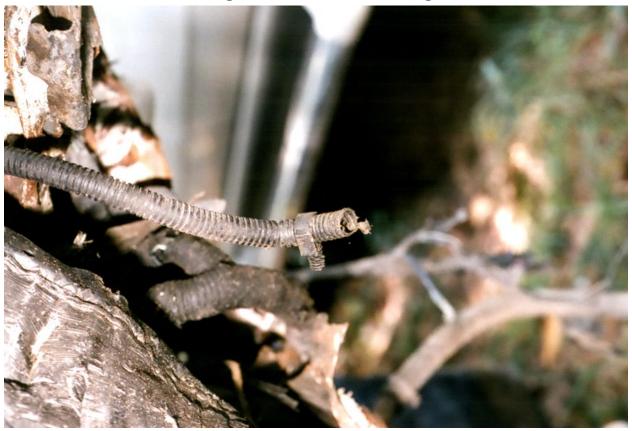
Cut wire harness (electrical connector was destroyed in crash) of 95

mustang

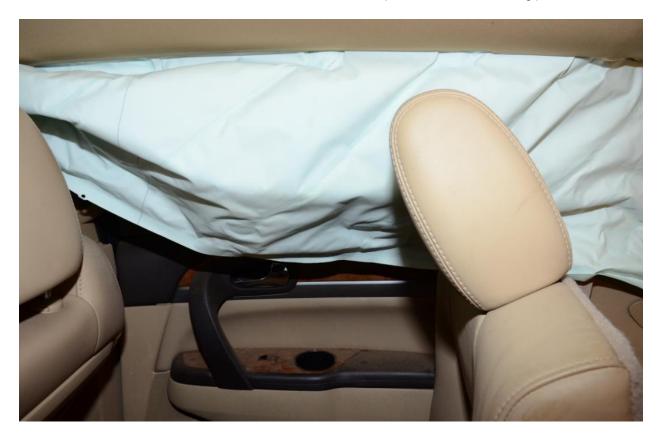
Inflated Side Rollover Curtain in GM Van (rear seat fatality)

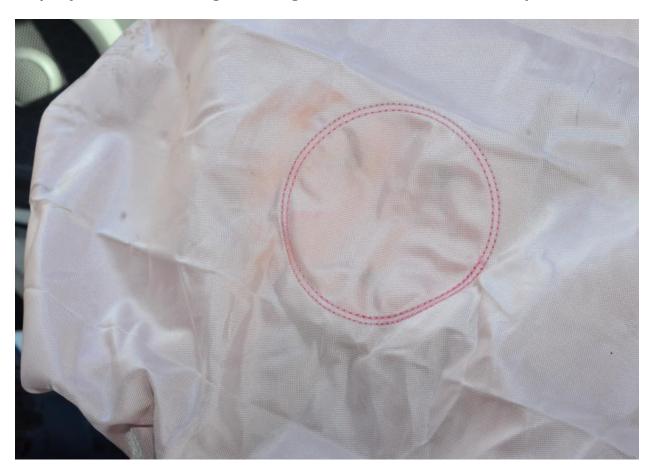
Deployed Driver Airbag showing contact with Driver Occupant
